Examples of Stormwater Problems

Here are pictures and descriptions of major stormwater projects in each district that Public Works would be able to address as soon as possible, if the City had adequate near-term revenue.

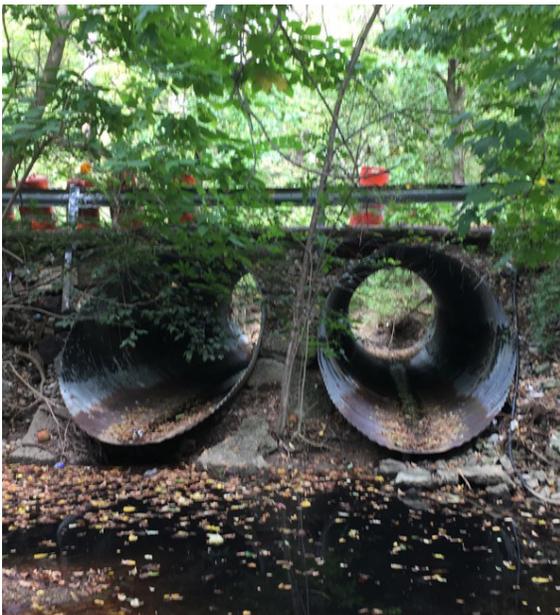
DISTRICT 3:
E Oak Cliff Ct

Rank: High Severity

Issue: The two large pipes under the road have started to rust away, which is costly to the integrity of the pipes. The side rails that are protecting the road will be caving in due to soil around the pipes eroding. Options to fix this issue are to line or replace the pipes. Replacing the pipes would be more intrusive and more expensive as this is the only road leading into several apartment complexes. The replacements would need to take place one side of the road at a time. Estimated cost shown is for replacing both pipes with concrete culverts.

Estimated cost of repair: \$550,000

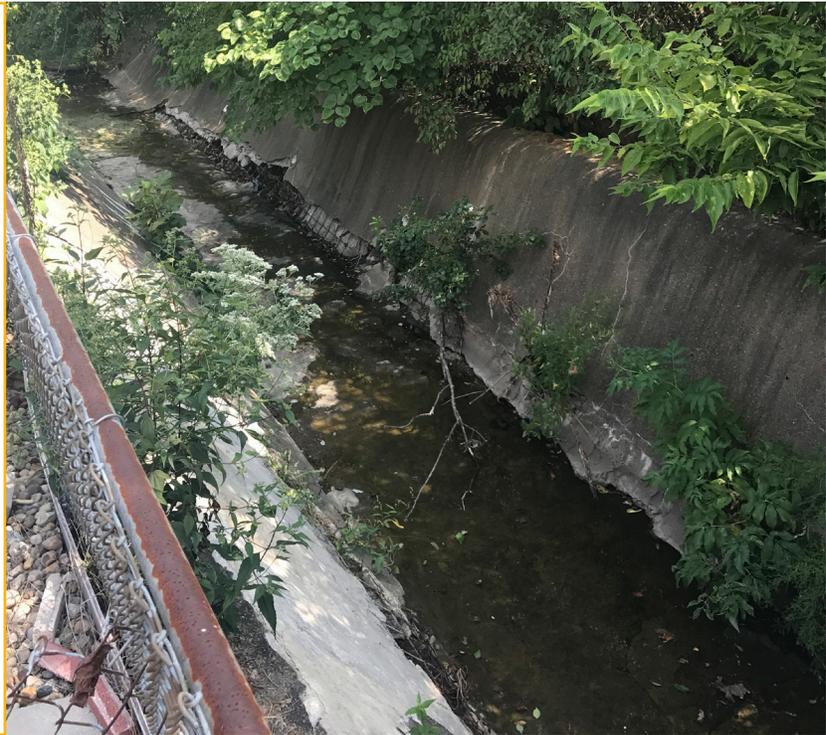
417 W Florence Ave

Rank: High Severity

Issue: Concrete wall reinforced with rebar is deteriorating along a creek that leads to a culvert. The wall extends a few blocks and is right up against the property lines of houses on either sides of the walls. The wall extends a few blocks and is adjacent to properties on either side. The cost represents the amount needed to prepare and reinforce the wall.

Estimated cost of repair:
\$80,000

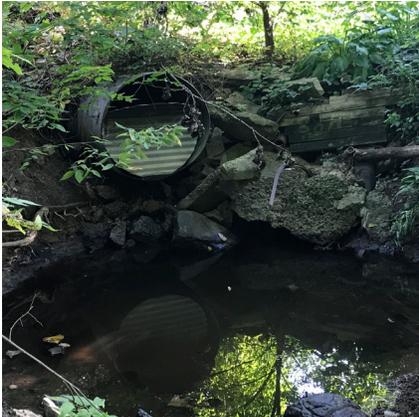
1202 W Oak Glen Dr

Rank: Medium Severity

Issue: The outfall at this location has erosion issues along with issues with the outfall not draining properly. This pipe outfall is fairly close to a property owner's retaining wall. The outfall of this pipe needs proper drainage, erosion control and ditch cleaning.

Estimated cost of repair:
\$20,000 – \$30,000

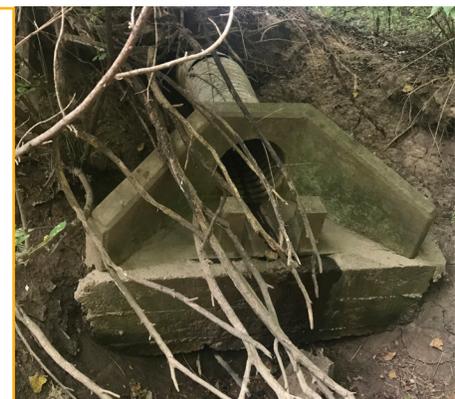
DISTRICT 4: 2910 W Winterberry Ln

Rank: High Severity

Issue: The pipe for this outfall is disconnected from the headwall. There is erosion around the headwall, which will lead to the headwall falling further into the creek. The concrete headwall could block the creek in the future if it isn't addressed. Repair cost would include repairing the pipe, headwall, and regrading the soil in this area.

Estimated cost of repair: \$40,000 – \$50,000

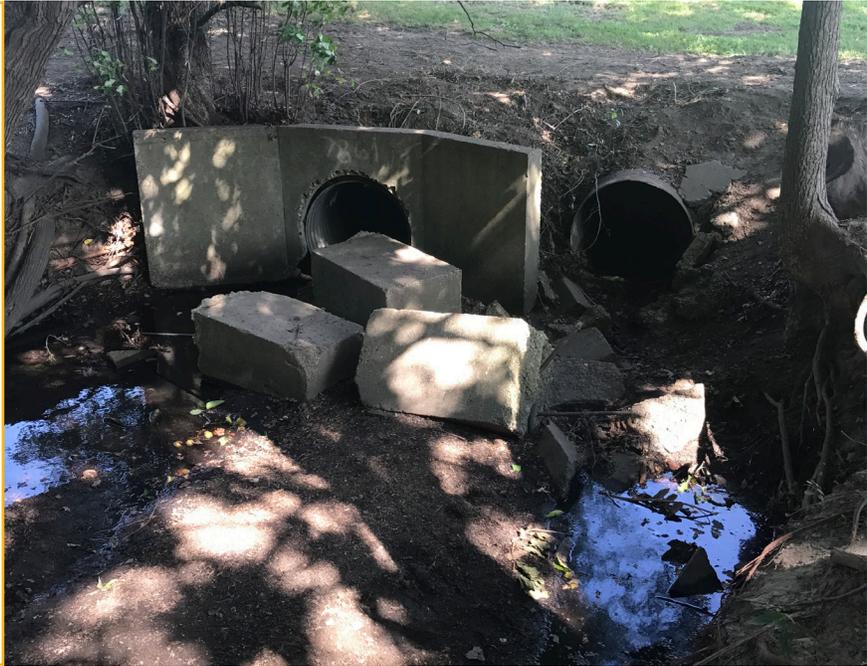
3601 N North St

Rank: Medium Severity

Issue: Outfall of the pipes are blocked by the headwall that has broken off from one of the pipes. The bottoms of the pipes are also missing. Estimated cost of repair would include lining the pipes, repairing the headwall and regrading the creek.

Estimated cost of repair:
\$30,000

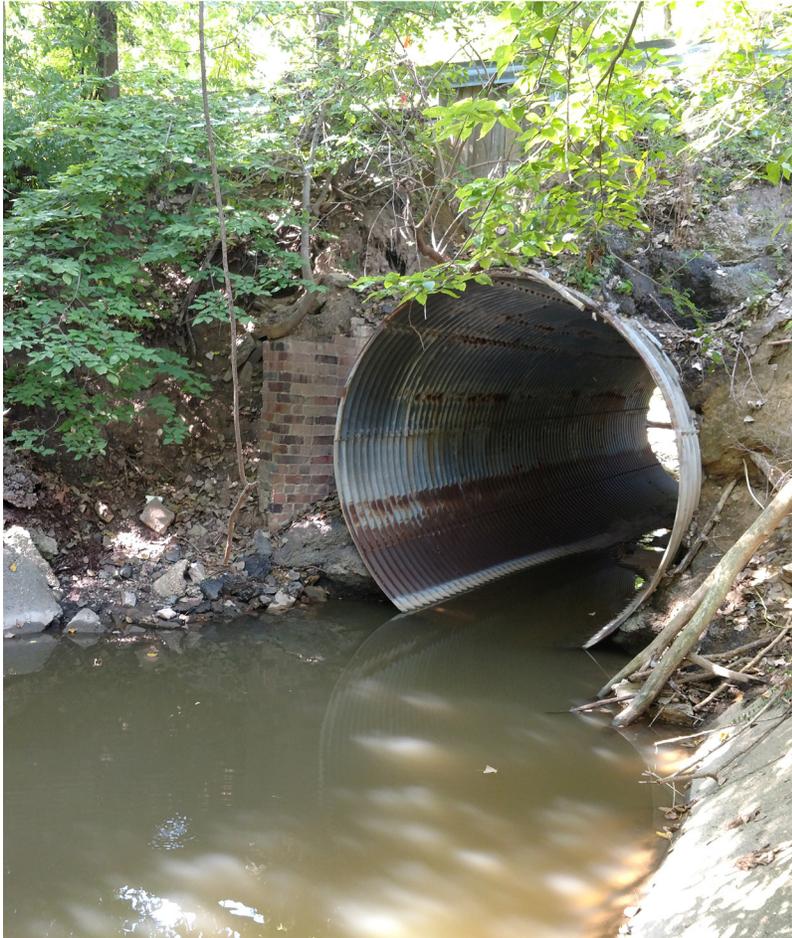
DISTRICT 2: Merle and Knoxville

Rank: High severity

Issue: Bottom of pipe is rusting out. The wall on top of the pipe is damaged, which is helping hold up the road. Repair consists of replacing culvert and regrading from the headwall to the road.

Estimated cost of repair:
\$500,000
